Final Report

CATCHMENT STUDY – GUSTAV CREEK, MAGNETIC ISLAND

ACTFR Report 00/05

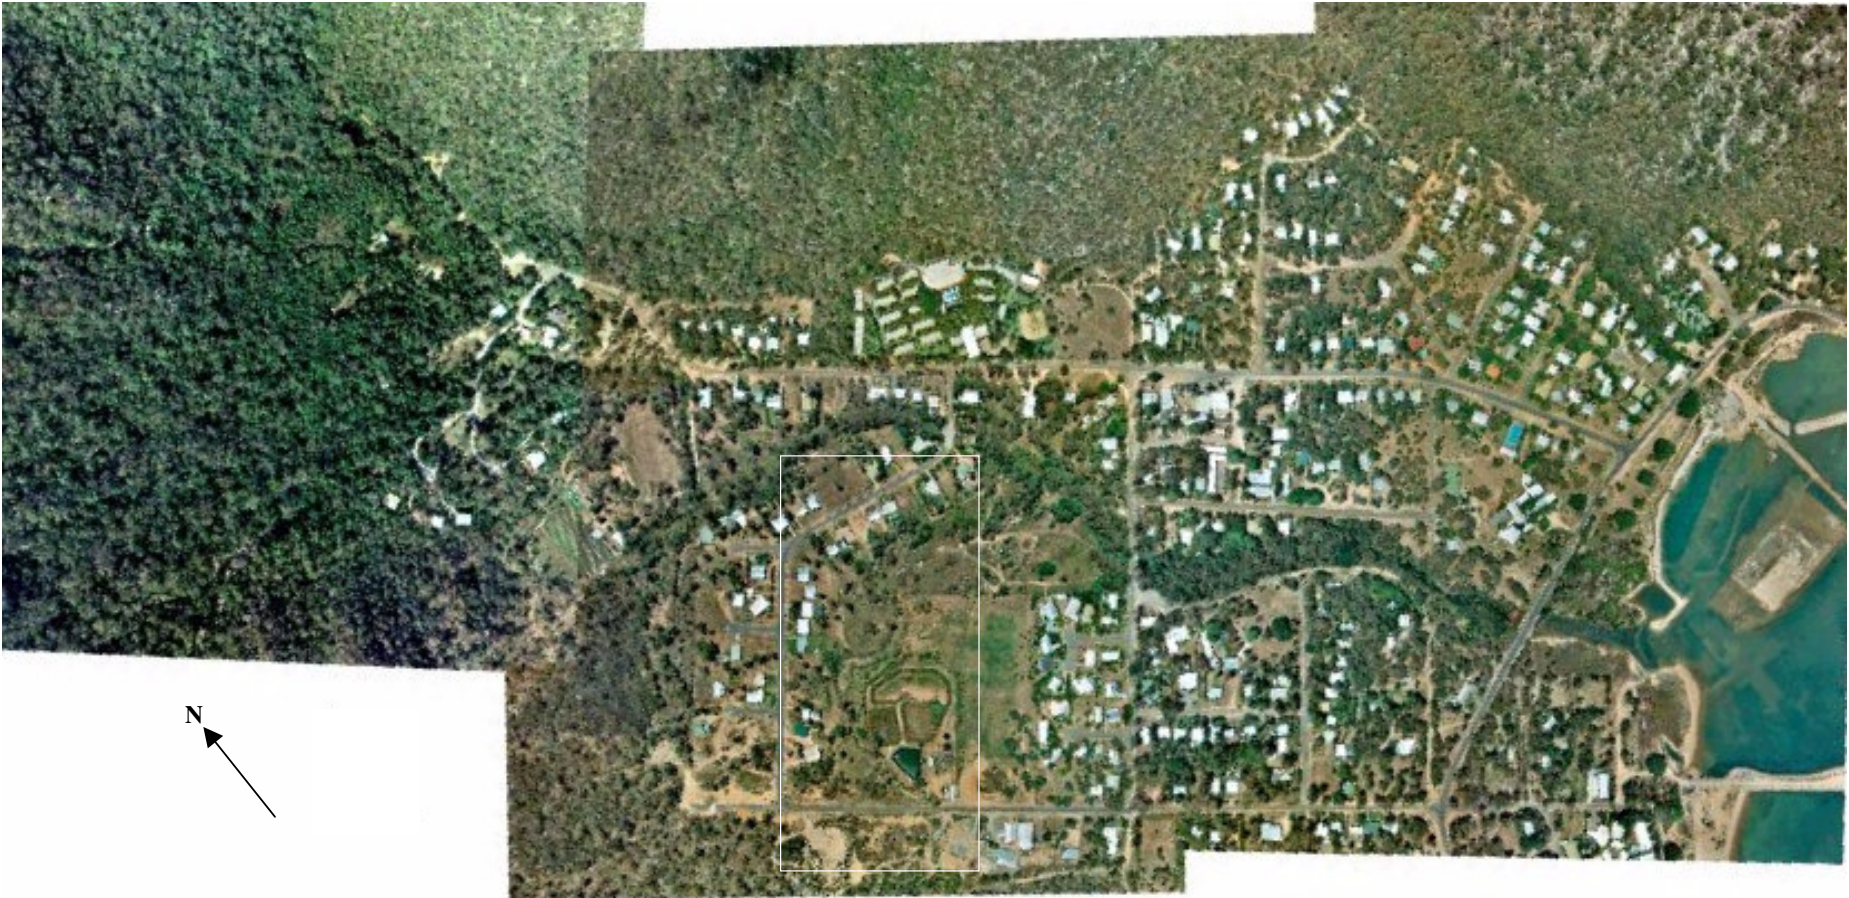
Figure 9.2: Aerial photograph of Nelly Bay township and Gustav Creek 1995.
(White rectangle shows area subject to major erosion in 1998 – see Figure B)

Hopley in McIntyre & Assoc. (1986b) reported that aerial photographs from 1941 onwards showed that the course of Gustav Creek has changed several times over the years and that its exact location was determined by a sand spit built from sediments transported down the creek during wet seasons. In 1941 and 1961, photographs showed the mouth of the creek completely closed off by the spit. The 1974 photograph, taken after a series of cyclones in preceding years (Cyclones Althea in 1971, Bronwyn in 1972, and Una in 1973) shows the spit disrupted and the creek flowing through the gap. The 1982 photograph shows the spit re-established and, in 1983, enclosing a small lagoon. The climate during subsequent years was strongly influenced by the El Nino effect and lower rainfalls were recorded (see Climate Section 3). Aerial photographs from 1999 show the landslides and erosion in Gustav Creek following severe storms in 1998. The harbour development has reduced build up of sand spits in the mouth of the creek (Figures 9.2 & 9.3).
