## 5. THE COASTAL ZONE

### 5.1 INTRODUCTION

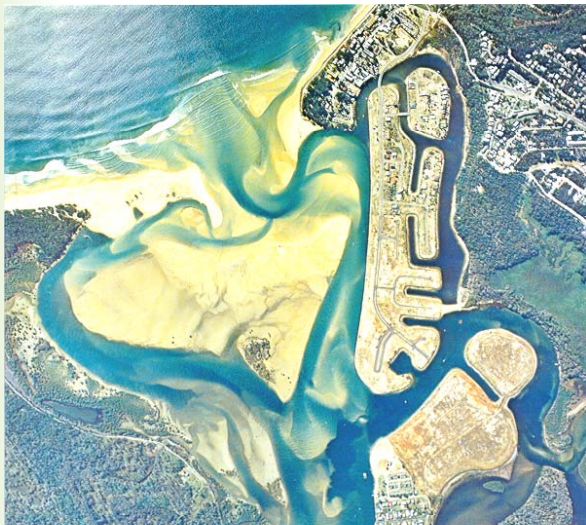
*May 1978, during construction of Noosa Sound Canal Estate*

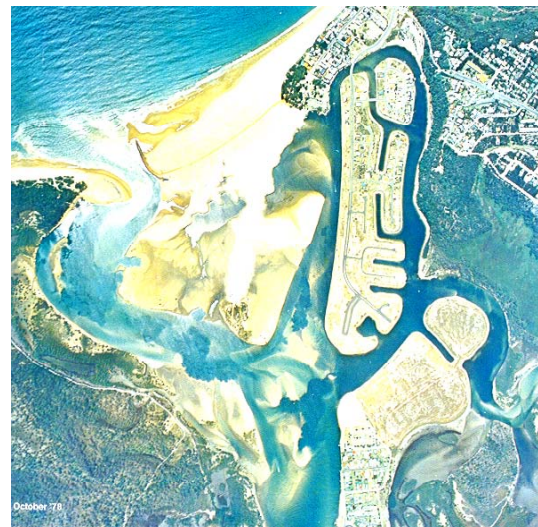
*October 1978, showing construction of the spit and changes underway in the river mouth*
