Energy Audit Dalrymple Road Depot

Inventory of Selected Facilities within Townsville City Council

Date: January 2002
Ref: 81808 (R38351)

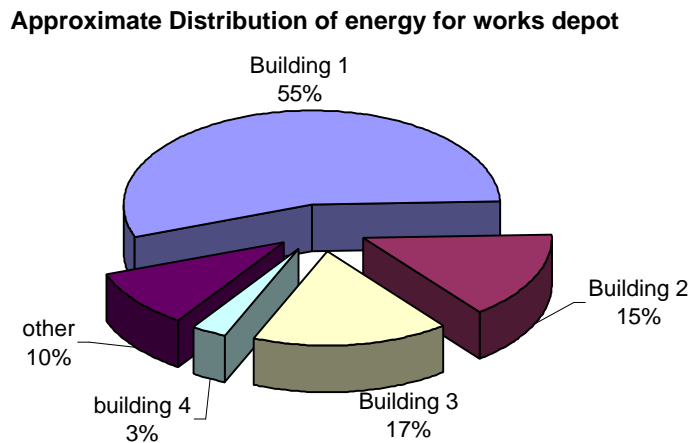
Figure 3: Approximate Energy distribution of Energy within Building

To indicate how recommendations will effect the overall energy bill,s it is necessary to identify how the energy is split between the facilities on the site. **Figure 3** indicates the approximate split in energy consumption for this site. As no direct metering information is available, and monitoring of this nature is beyond the scope of this audit, it is necessary to base these splits on site observations and previous audit work on similar facilities. Further to this, it is necessary to identify where the energy is consumed within each building to determine how long each recommendation would take to pay for itself (this only applies when capital investment is required). For accurate cost analysis to be carried out it would be necessary to firm these percentages up. Again these building demographics are based on site observations, standard data³ and previous audits of similar buildings. These percentages are indicated in **Figure 4**.
